CITY OF PORT HURON, MICHIGAN

**Dye Testing and
Private Property Inflow Source
Investigation**

SEVENTH AND NINTH STREETS

January 2001

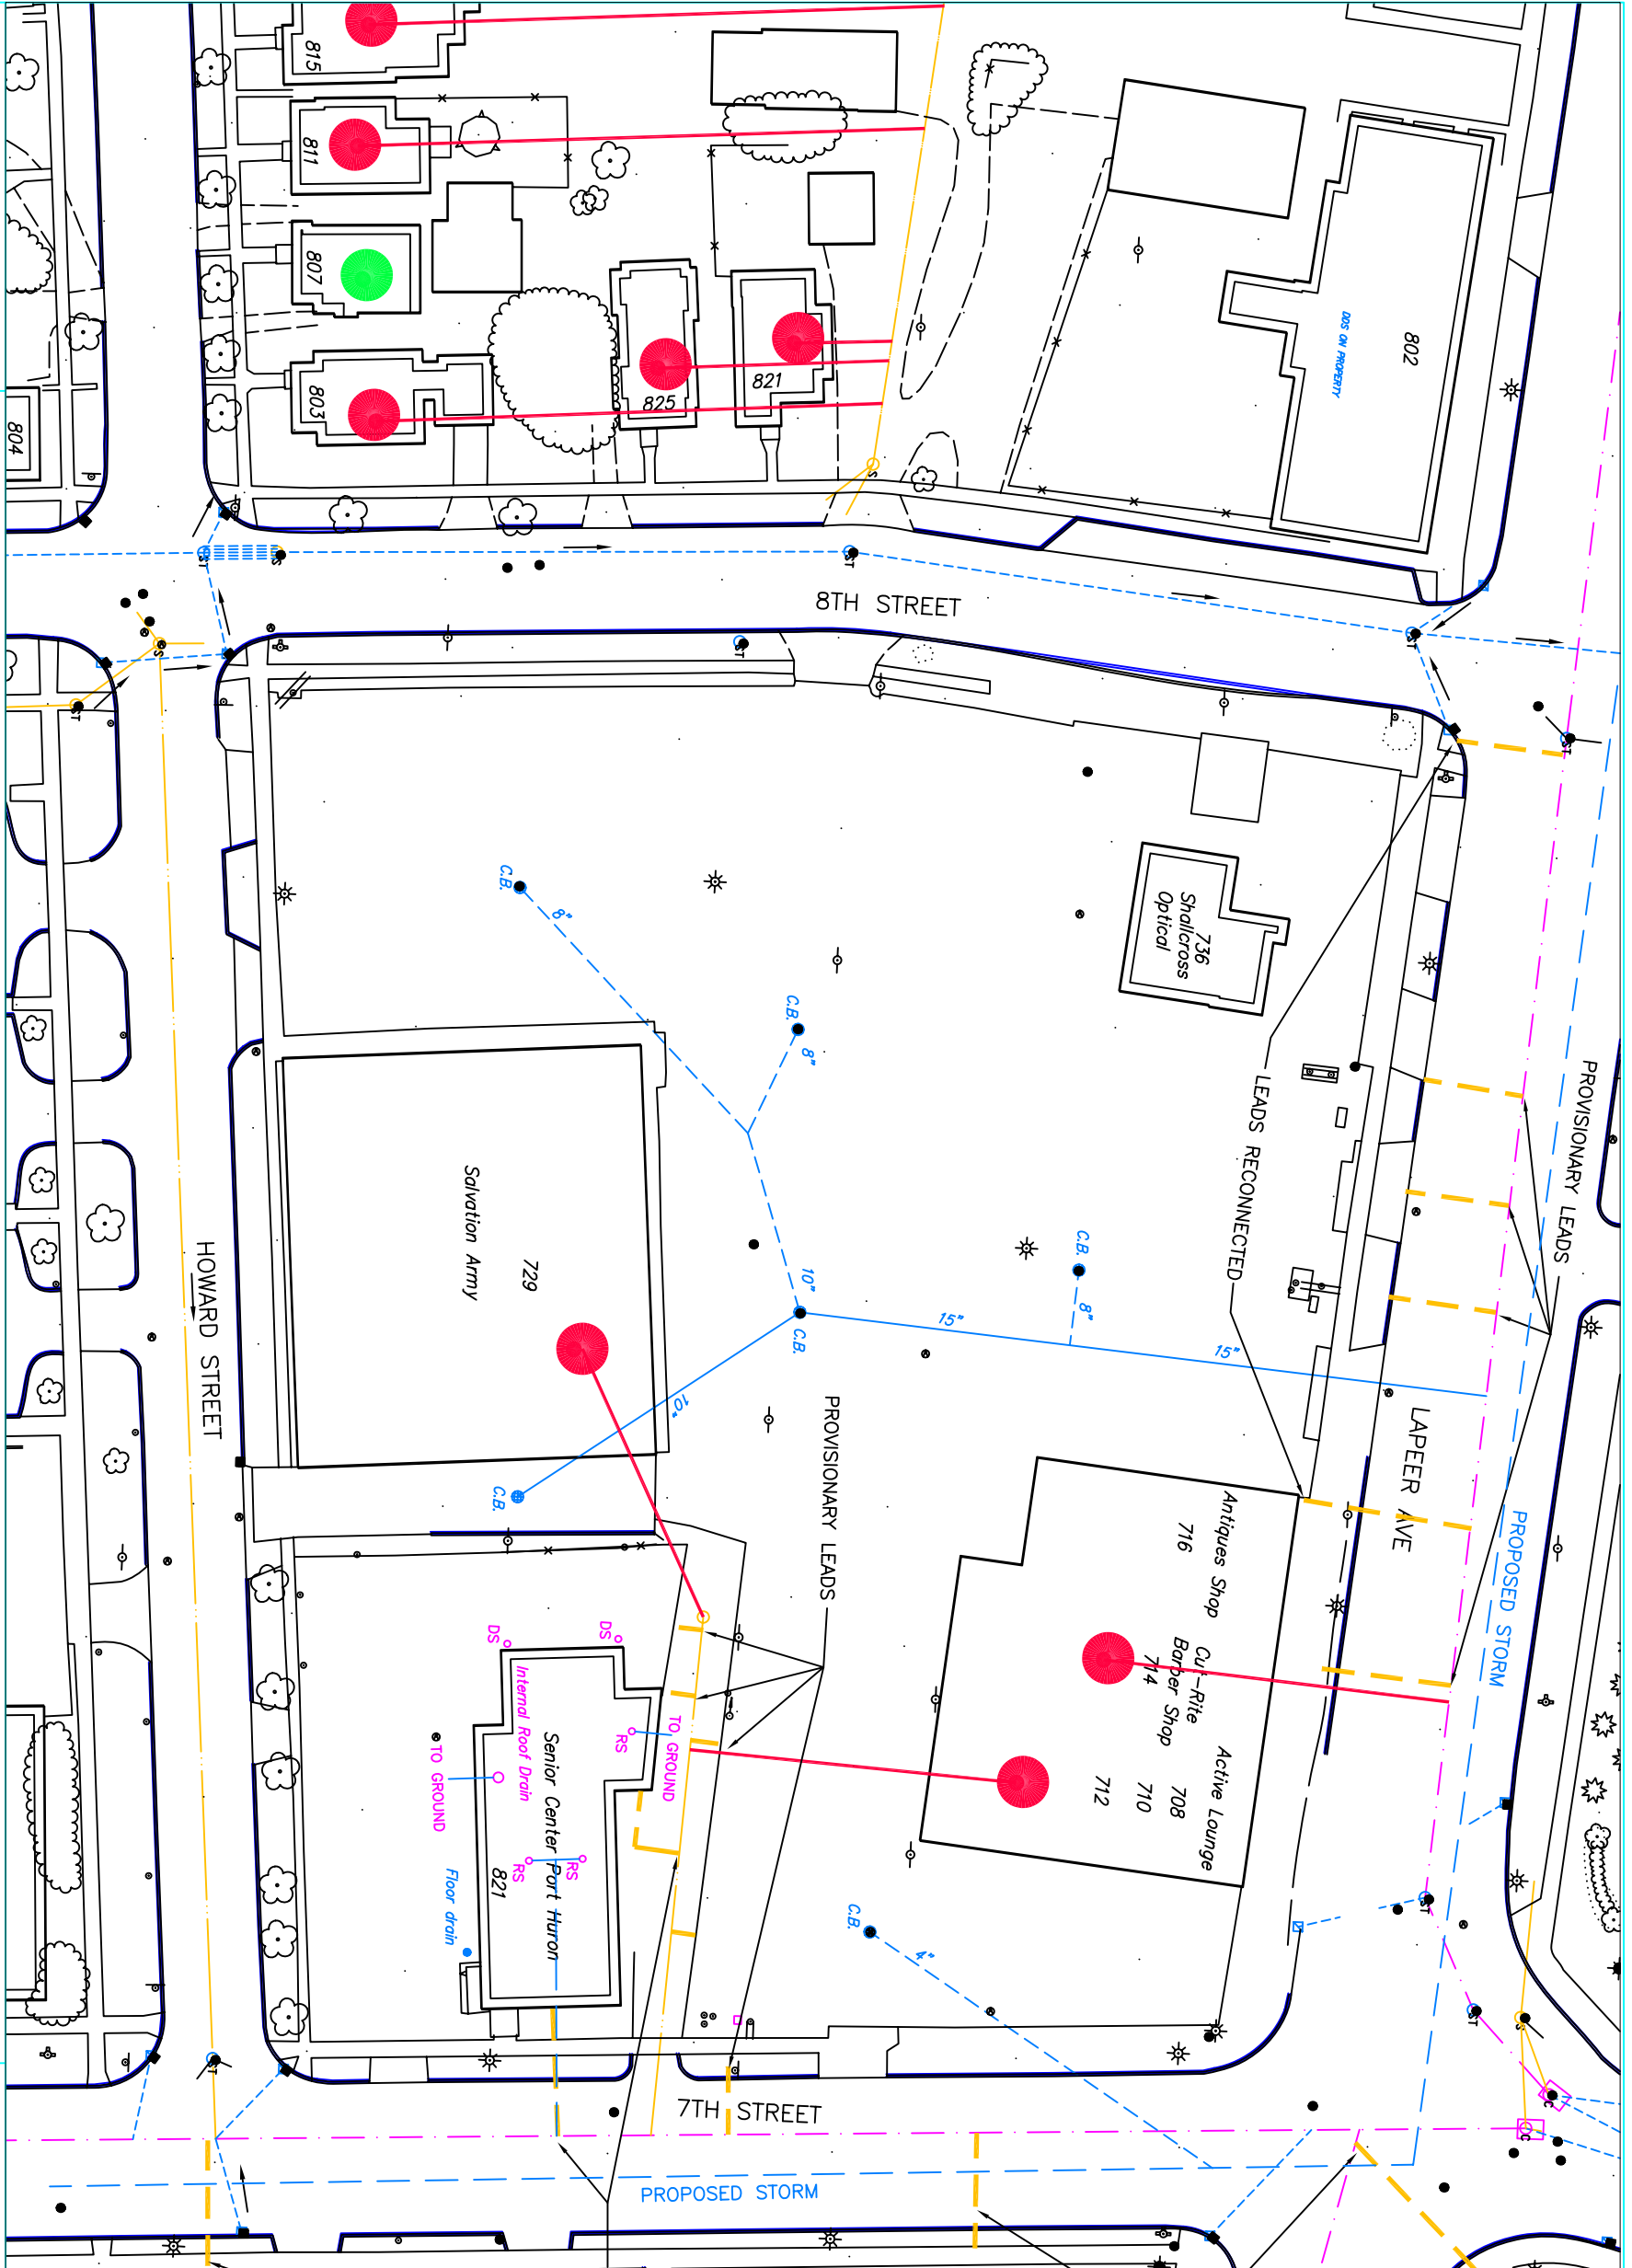
FIGURE
5

BLUE WATER FOOD CENTER - RESTROOM DYE TESTED TO NEW SEWER GOING TO SANITARY SEWER ON 7TH STREET.

708-716 LAPEER - LEAD NOT FOUND FOR 708-712. ROWE LEFT LEAD IN ALLEY AND LAPEER FOR FUTURE CONNECTION. 714-716 LEAD FOUND AND CONNECTED IN LAPEER.

SHALLCROSS OPTICAL SITE FOUND OK.

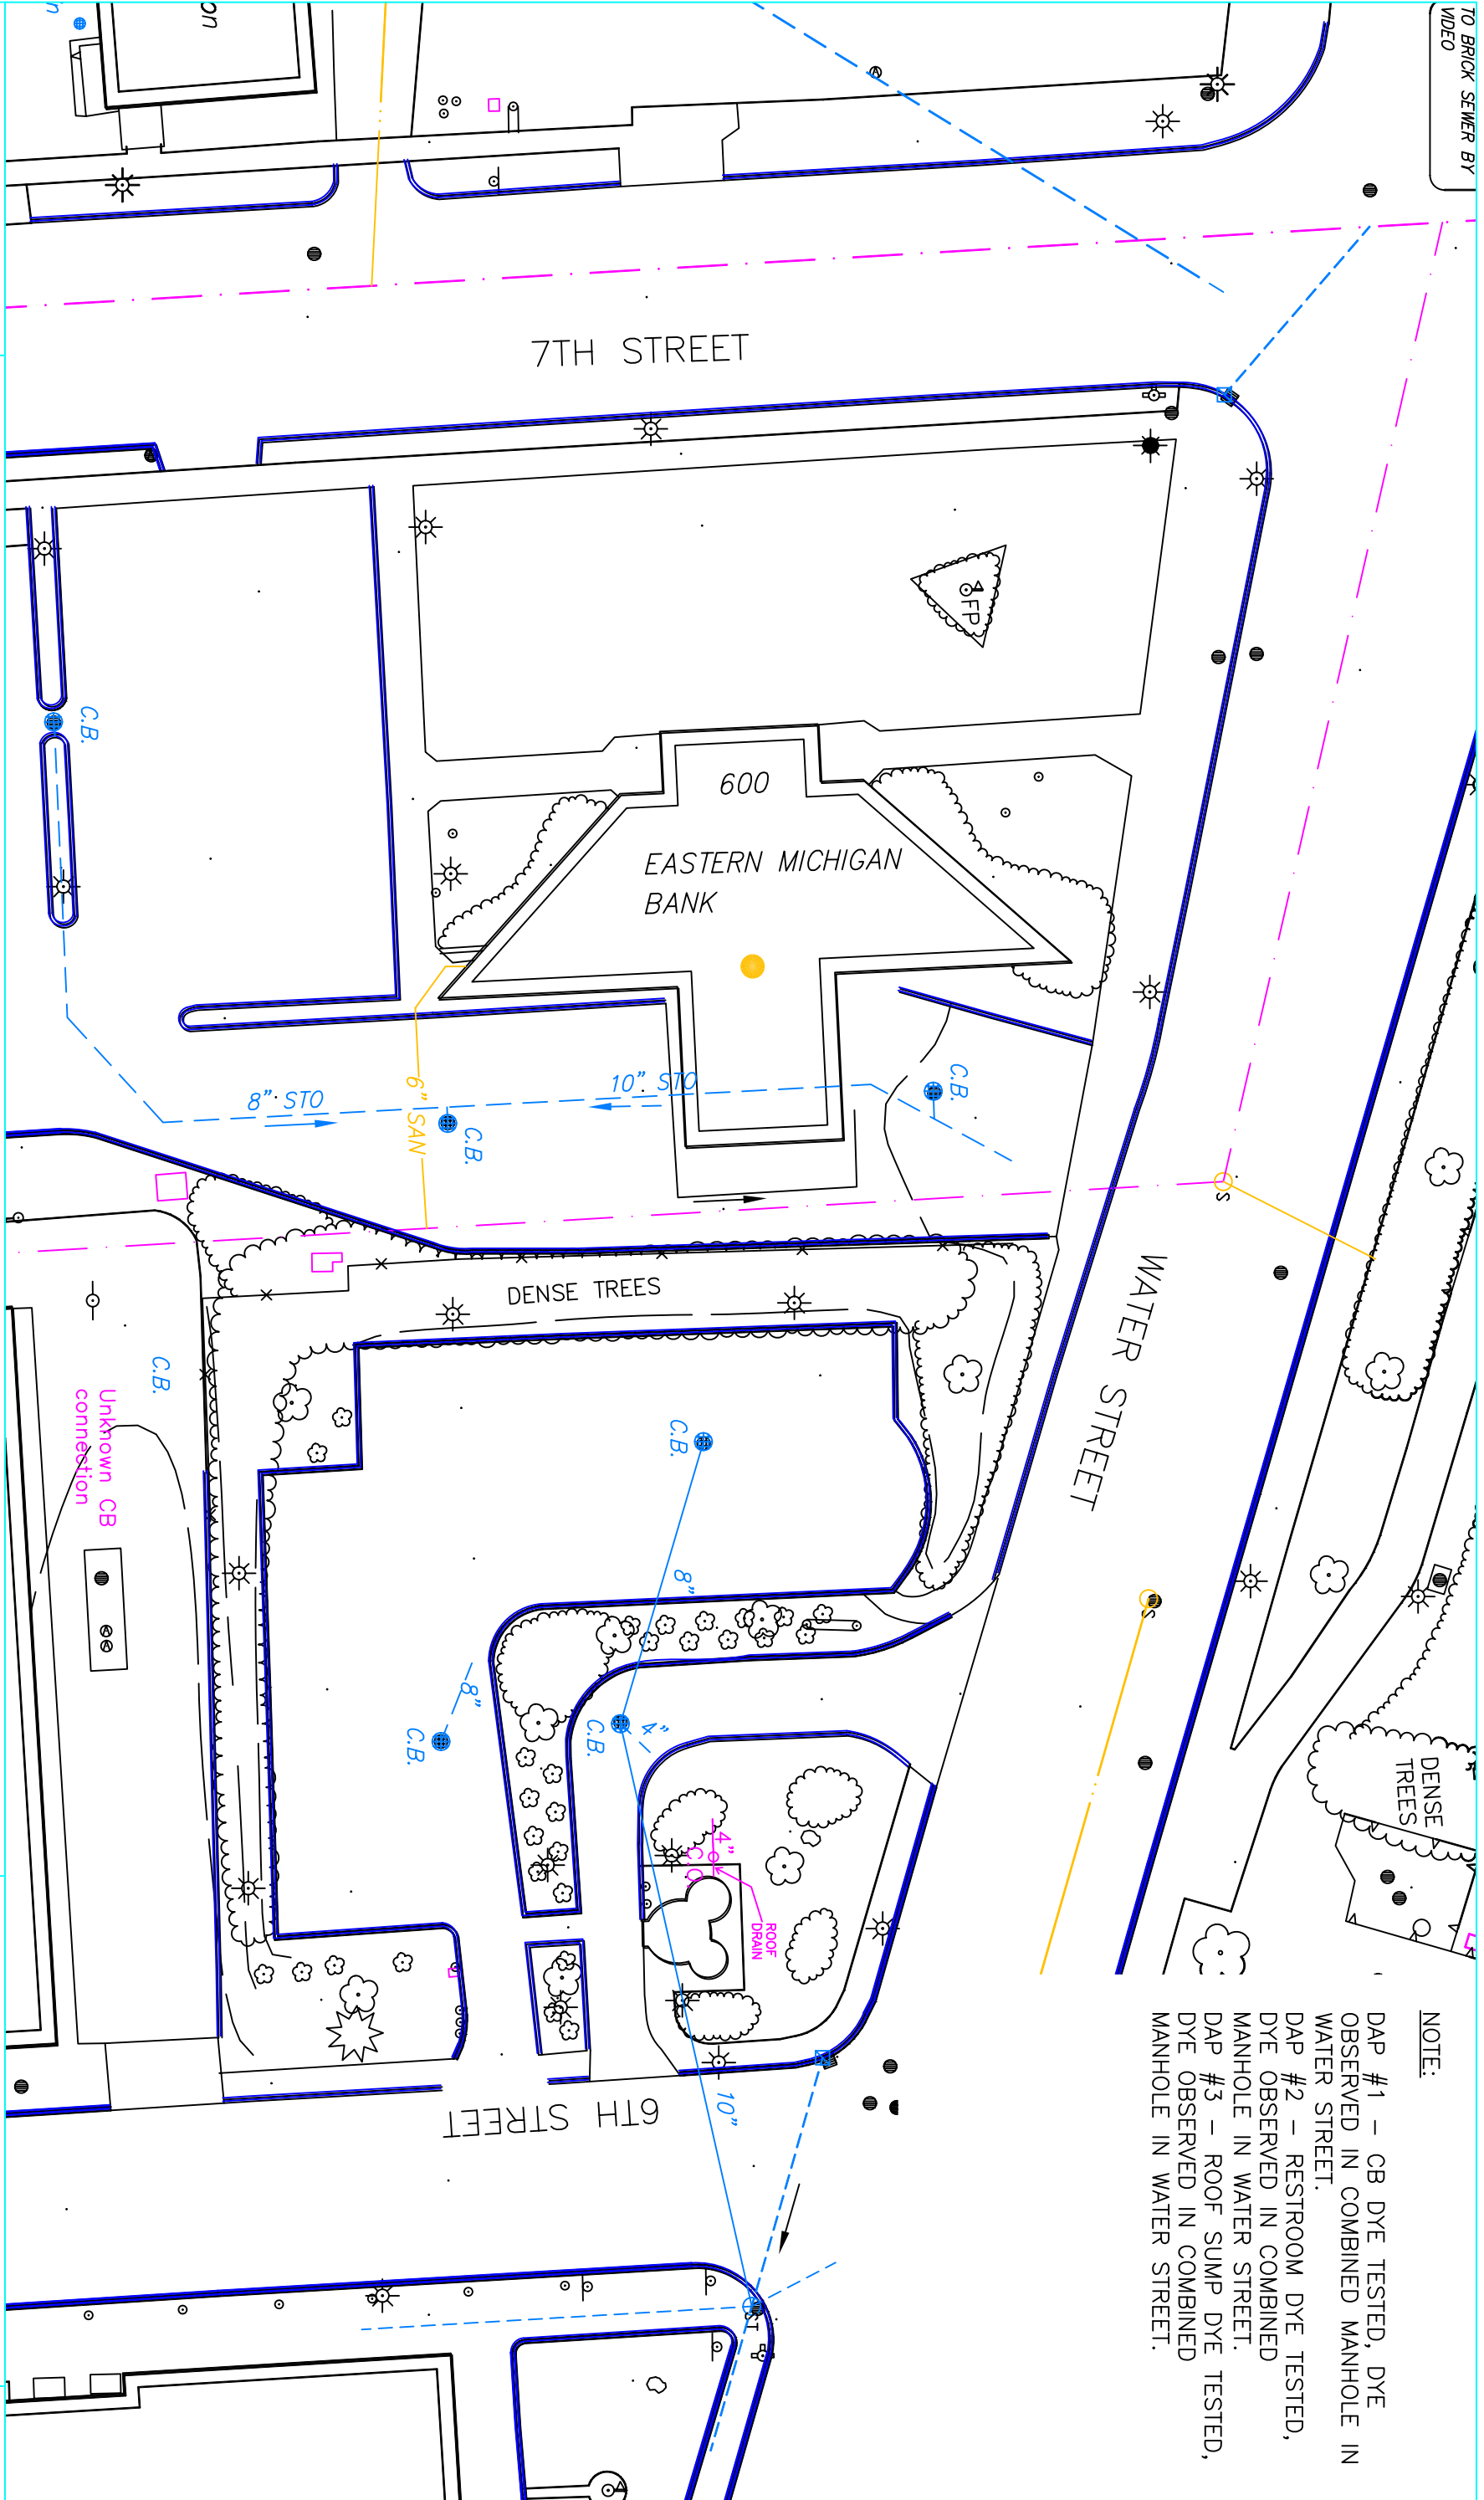
NOTE:
 DAP #1 - CB DYE TESTED, DYE OBSERVED IN COMBINED MANHOLE IN WATER STREET.
 DAP #2 - RESTROOM DYE TESTED, DYE OBSERVED IN COMBINED MANHOLE IN WATER STREET.
 DAP #3 - ROOF SUMP DYE TESTED, DYE OBSERVED IN COMBINED MANHOLE IN WATER STREET.

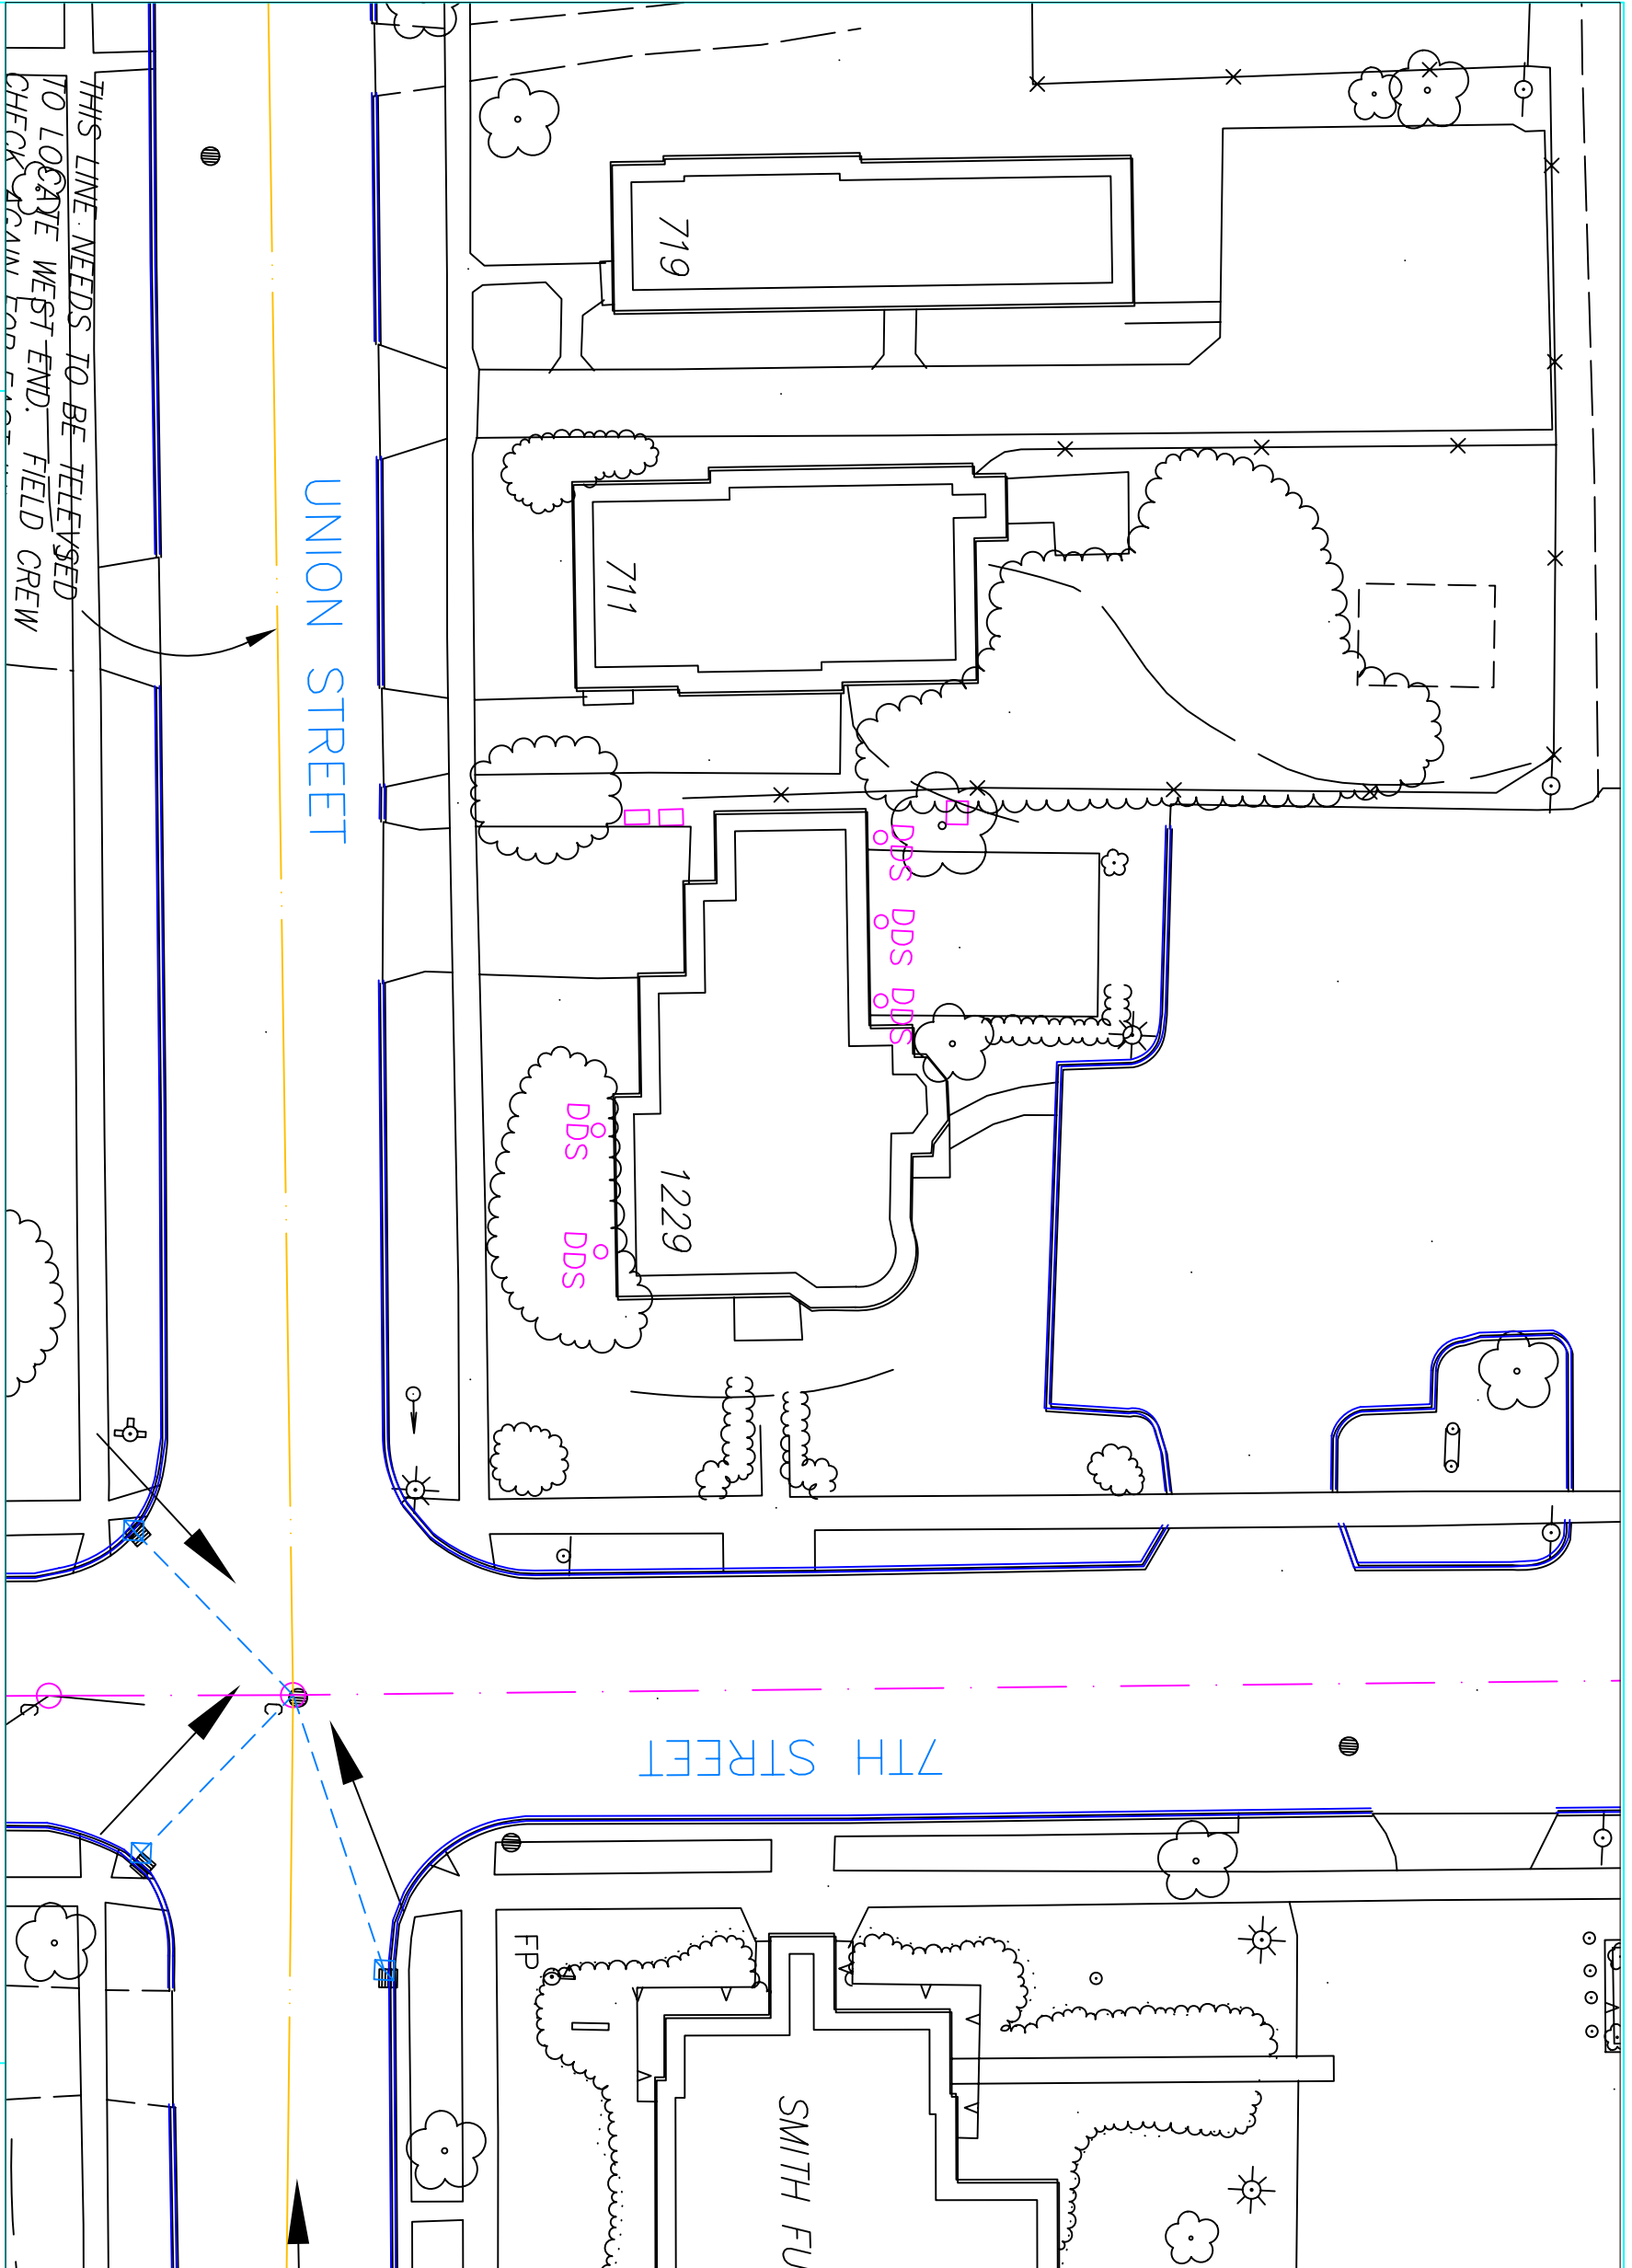
THIS LINE NEEDS TO BE TELEVISED TO LOCATE WEST-END. FIELD CREW CHECK AGAIN FOR THIS LINE
