Miami-Dade  
Water and Sewer Department

# Comprehensive Lateral Investigation Program (CLIP)

## Preliminary Draft Report

May 2006

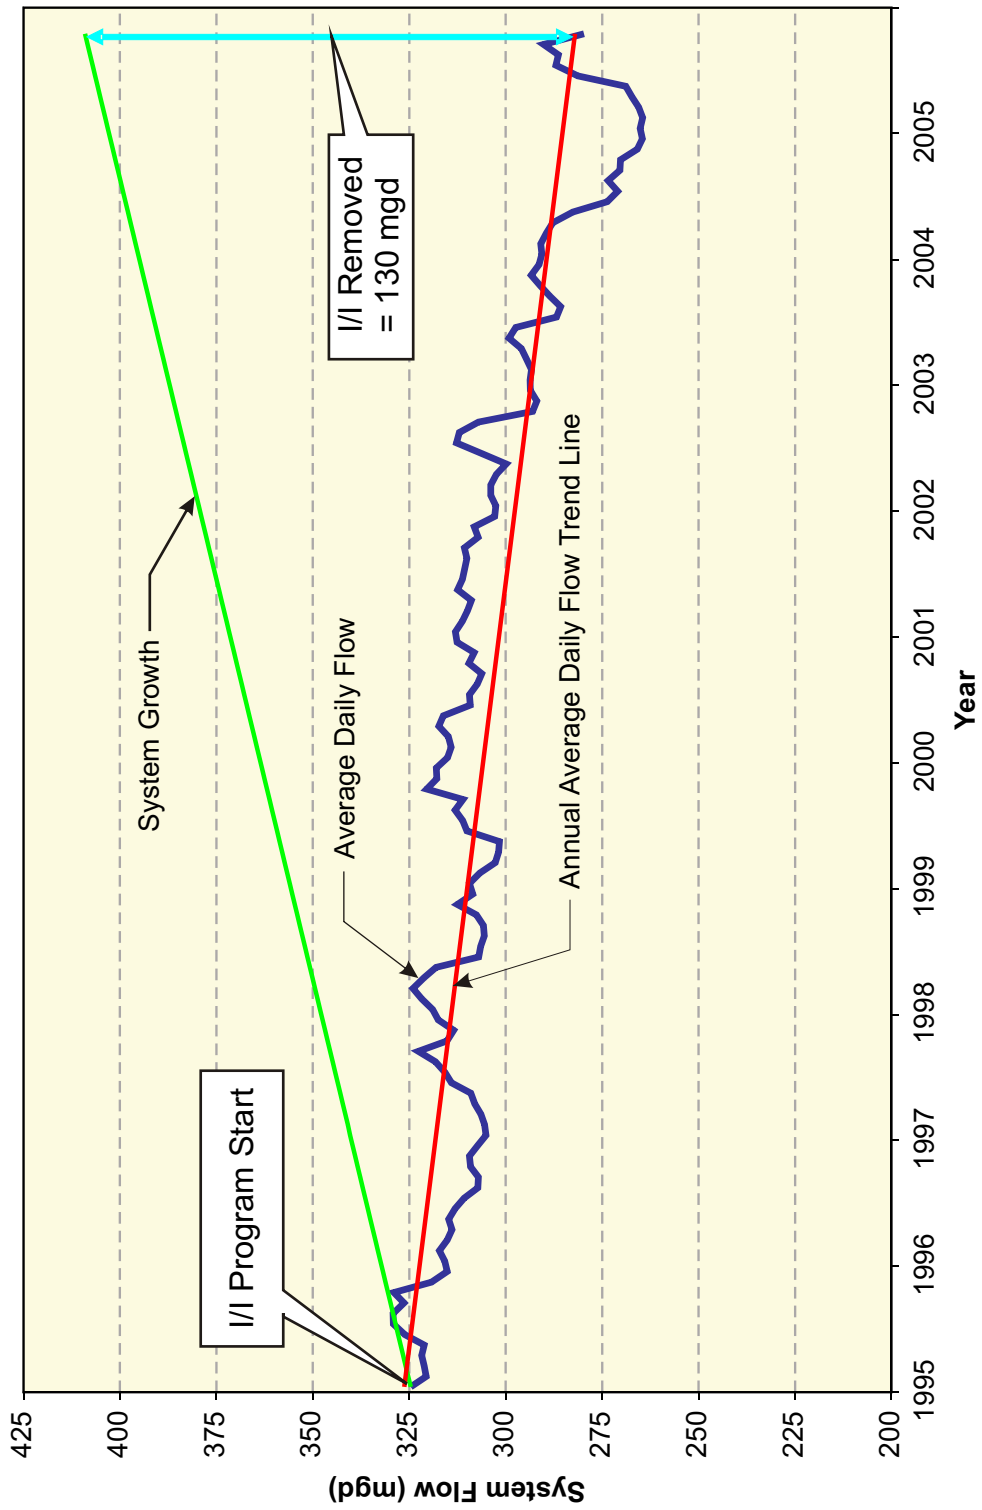
Figure 2-1  
I/I Program Results

As indicated in Figure 2-1, the I/I Program has been highly successful with system flows to the regional treatment facilities reduced by approximately 130 mgd. Although the system-wide infiltration was greatly reduced, rainfall dependent infiltration/inflow (RDII) and improvements to the transmission system have continued to increase the peak flows to the treatment facilities during heavy rainfall events. It is estimated that approximately 500 of the 960 pump stations continue to exhibit a RDII signature. Since the mainline sewer components were fully investigated and laterals from the main sewer to the house (house lateral) have only been evaluated in close proximity to the mainline sewer, the sewer house laterals have been identified as the only system component not fully investigated.

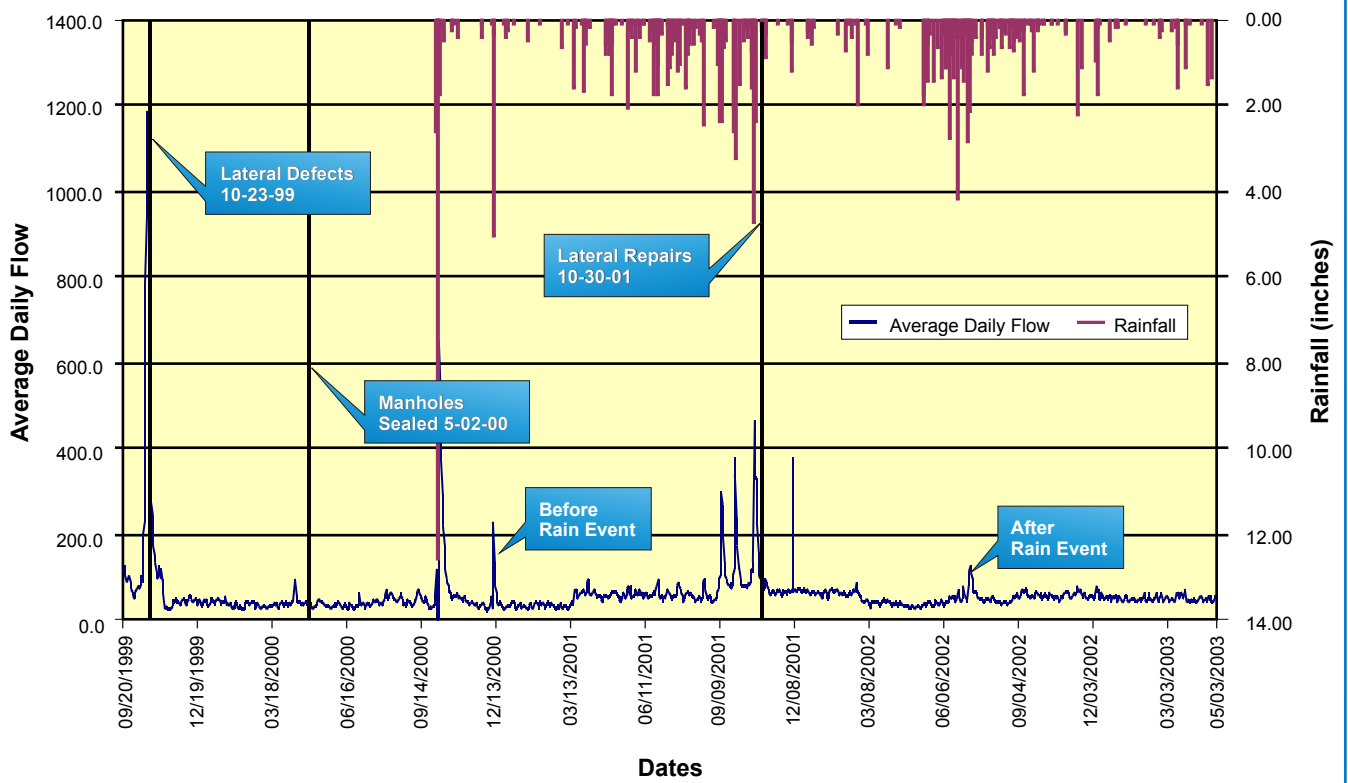
**Figure 5-3**  
Typical Hydrograph

Figure 5-3 is a typical hydrograph developed under the Program. The graph shows the basin flow, rainfall and groundwater levels during the past five year period. As shown on the graph, rainfall events raise the groundwater table and increase the collection basin flows to the pump station.

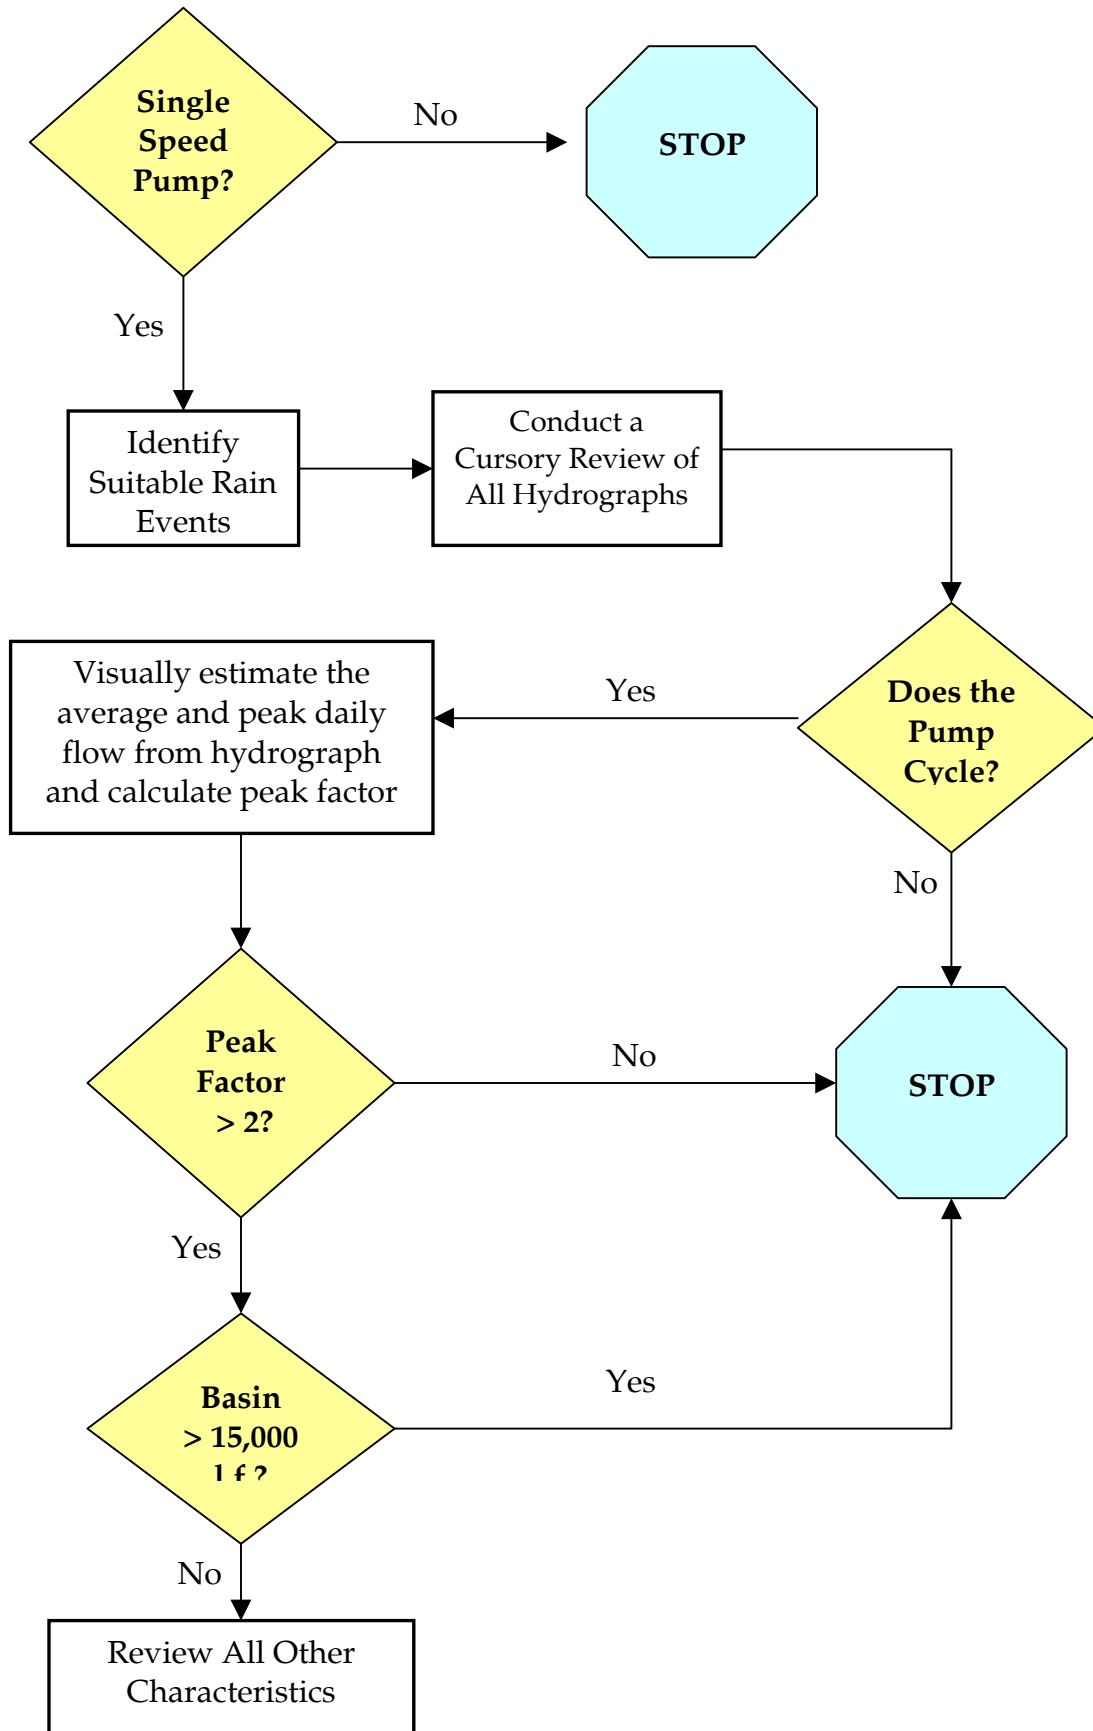
Figure 2-1  
CLIP Basin Selection Protocol Flow Sheet

The first step in developing the protocol was determining conditions for evaluating the pump station's performance. The primary goal of the CLIP is to reduce the amount of RDII flow that is pumped and treated during rainfall events that produce approximately 4.5 inches of rain during a 24-hour period. In a Consent Decree with the Environmental Protection Agency (EPA), MDWASD agreed to meet several
