CITY OF PORT HURON, MICHIGAN

**Dye Testing and
Private Property Inflow Source
Investigation**

SEVENTH AND NINTH STREETS

January 2001

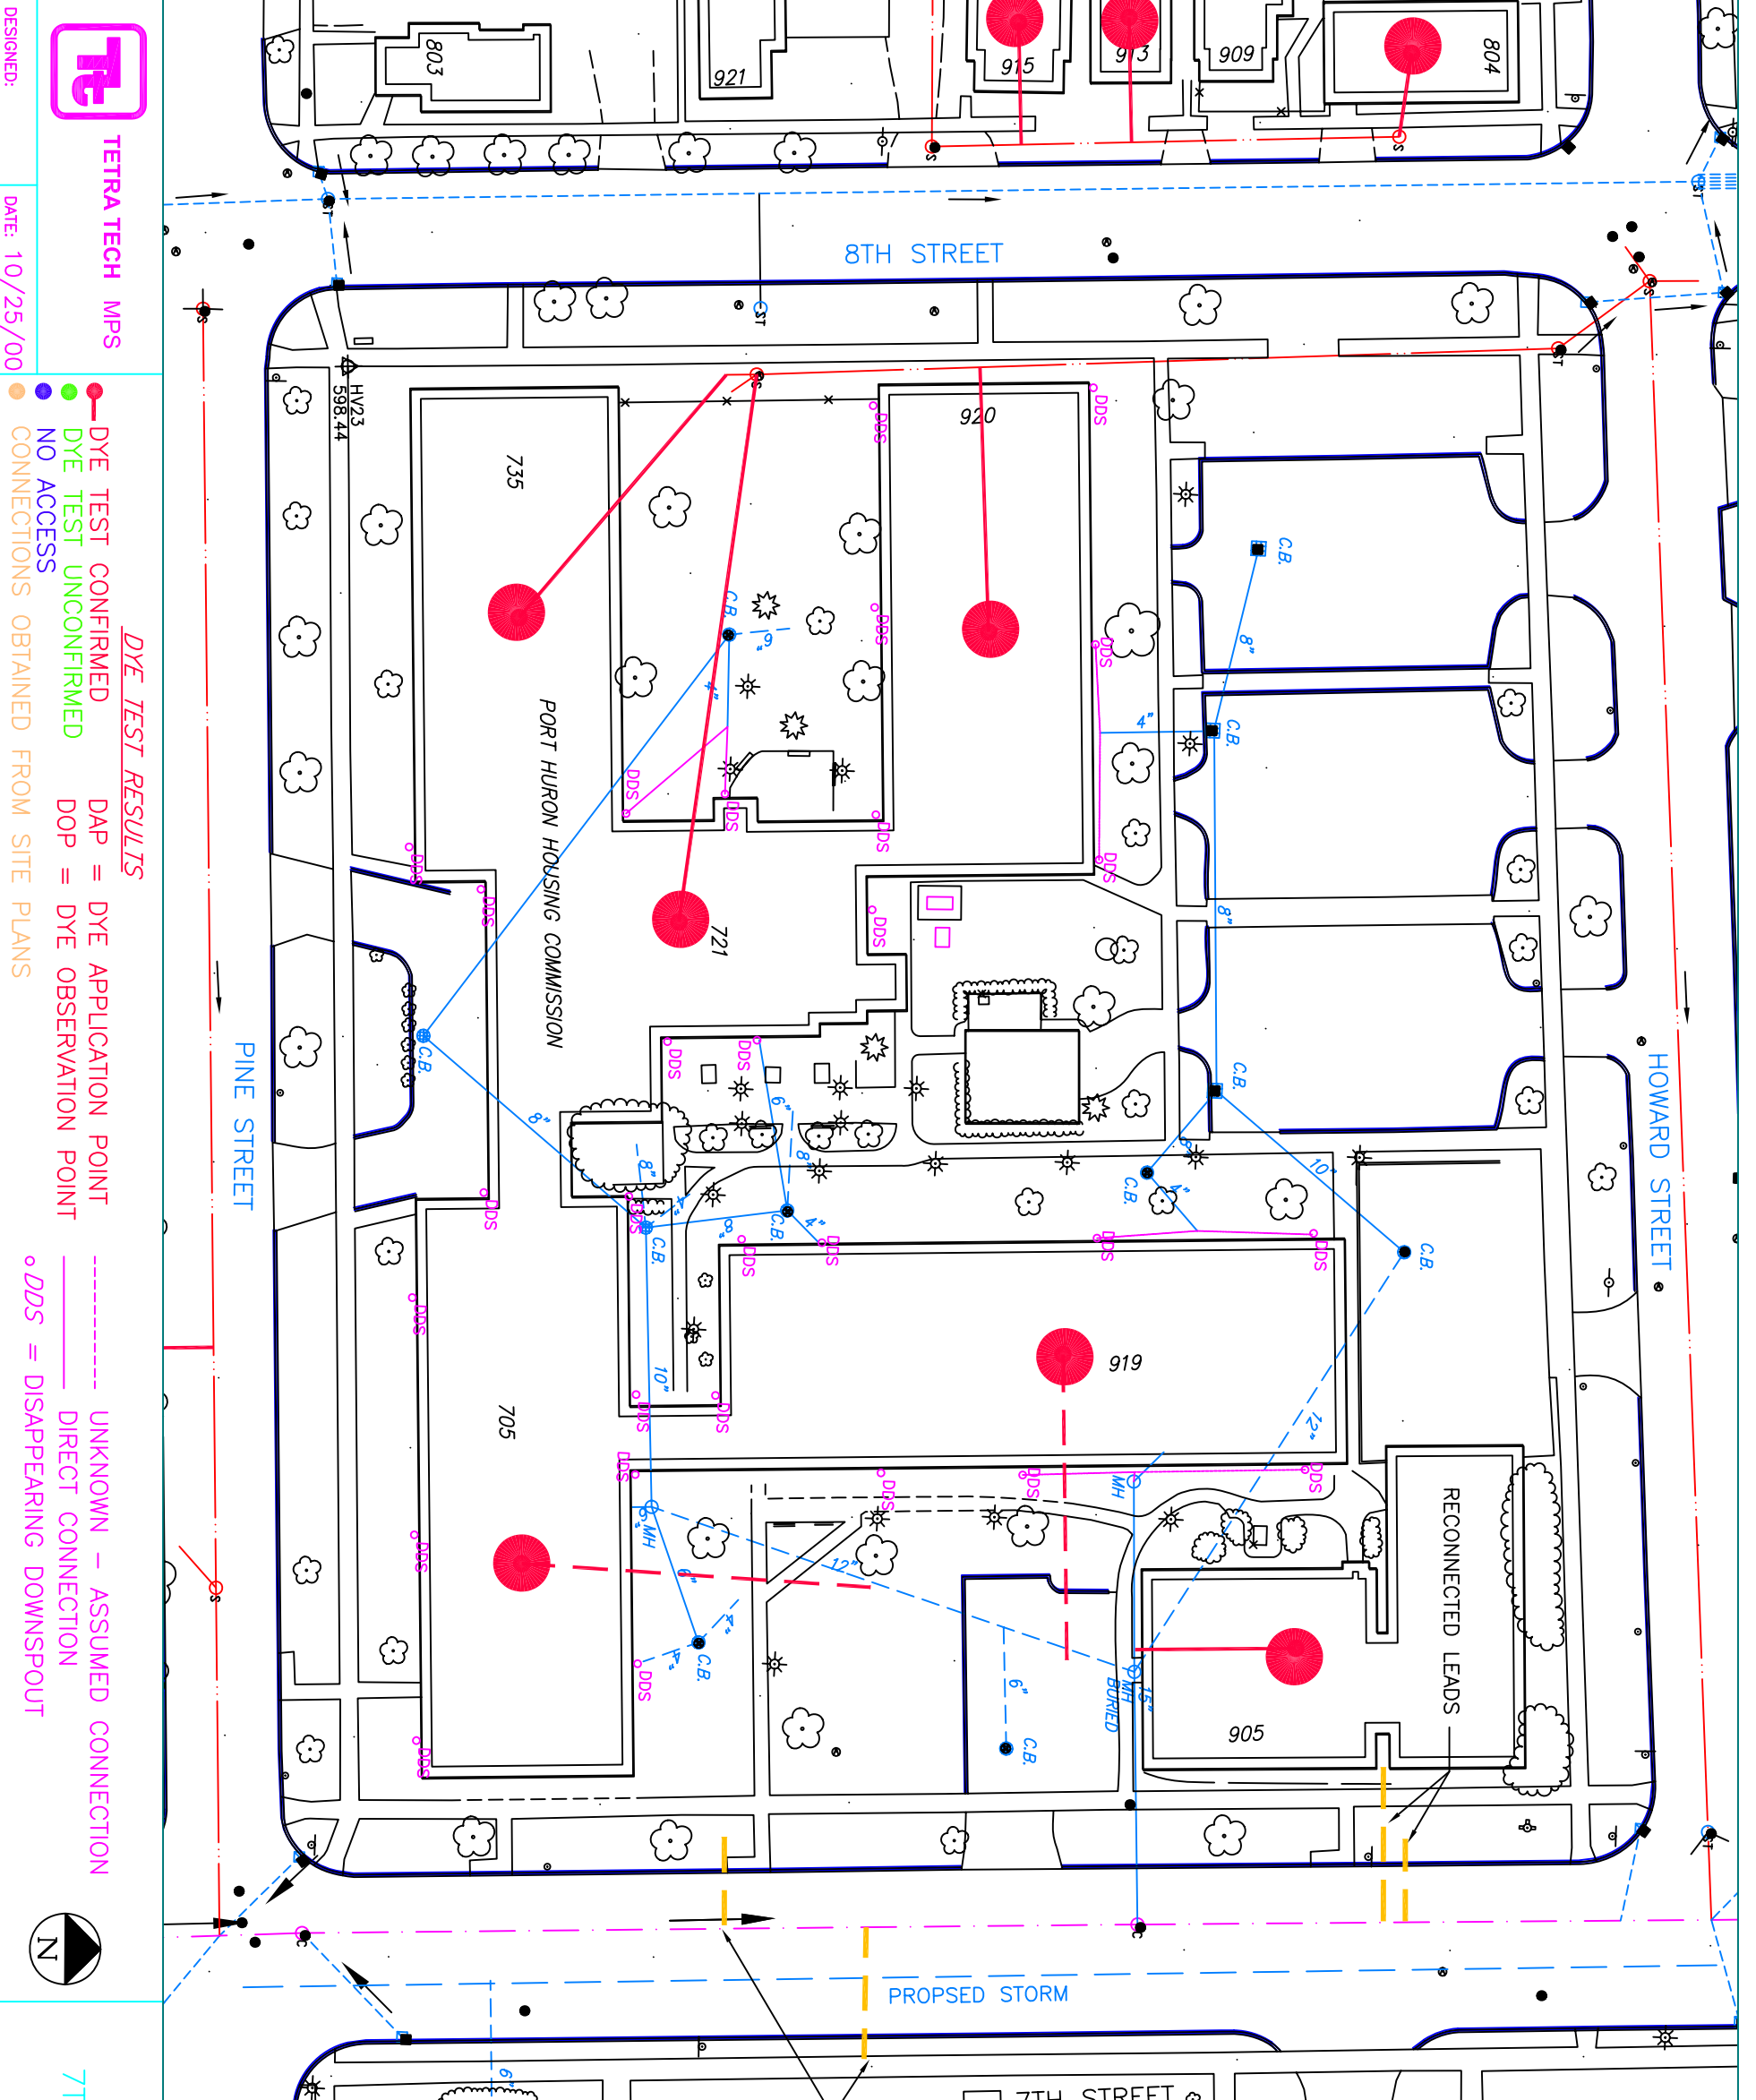
FIGURE
5

<ol style="list-style-type: none"> 1. 708, 710 & 712 Lapeer Ave. (Active Lounge) 2. 714 Lapeer Ave. (Cut-Rite Barber Shop) 3. 716 Lapeer Ave. (Antiques) 4. 	Catch basins in parking lot, refer to Figure 5.	Owner to determine CB connection. City to provide storm lead to parking lot CBs.
736 Lapeer Ave. (Shallcross Optical)	Catch basins in parking lot, refer to Figure 5.	City to provide storm lead to parking lot CBs.
905 & 919 7 th Street; 705, 721, 735 Pine Street; 920 8 th Street. (Port Huron Housing Commission Office)	Catch basin in parking lot and disappearing downspout on property; refer to Figure 6.	City to provide storm or sanitary lead to building on 7 th Street. Owner must determine disappearing downspout and CB connections. Owner must separate private combined lines.

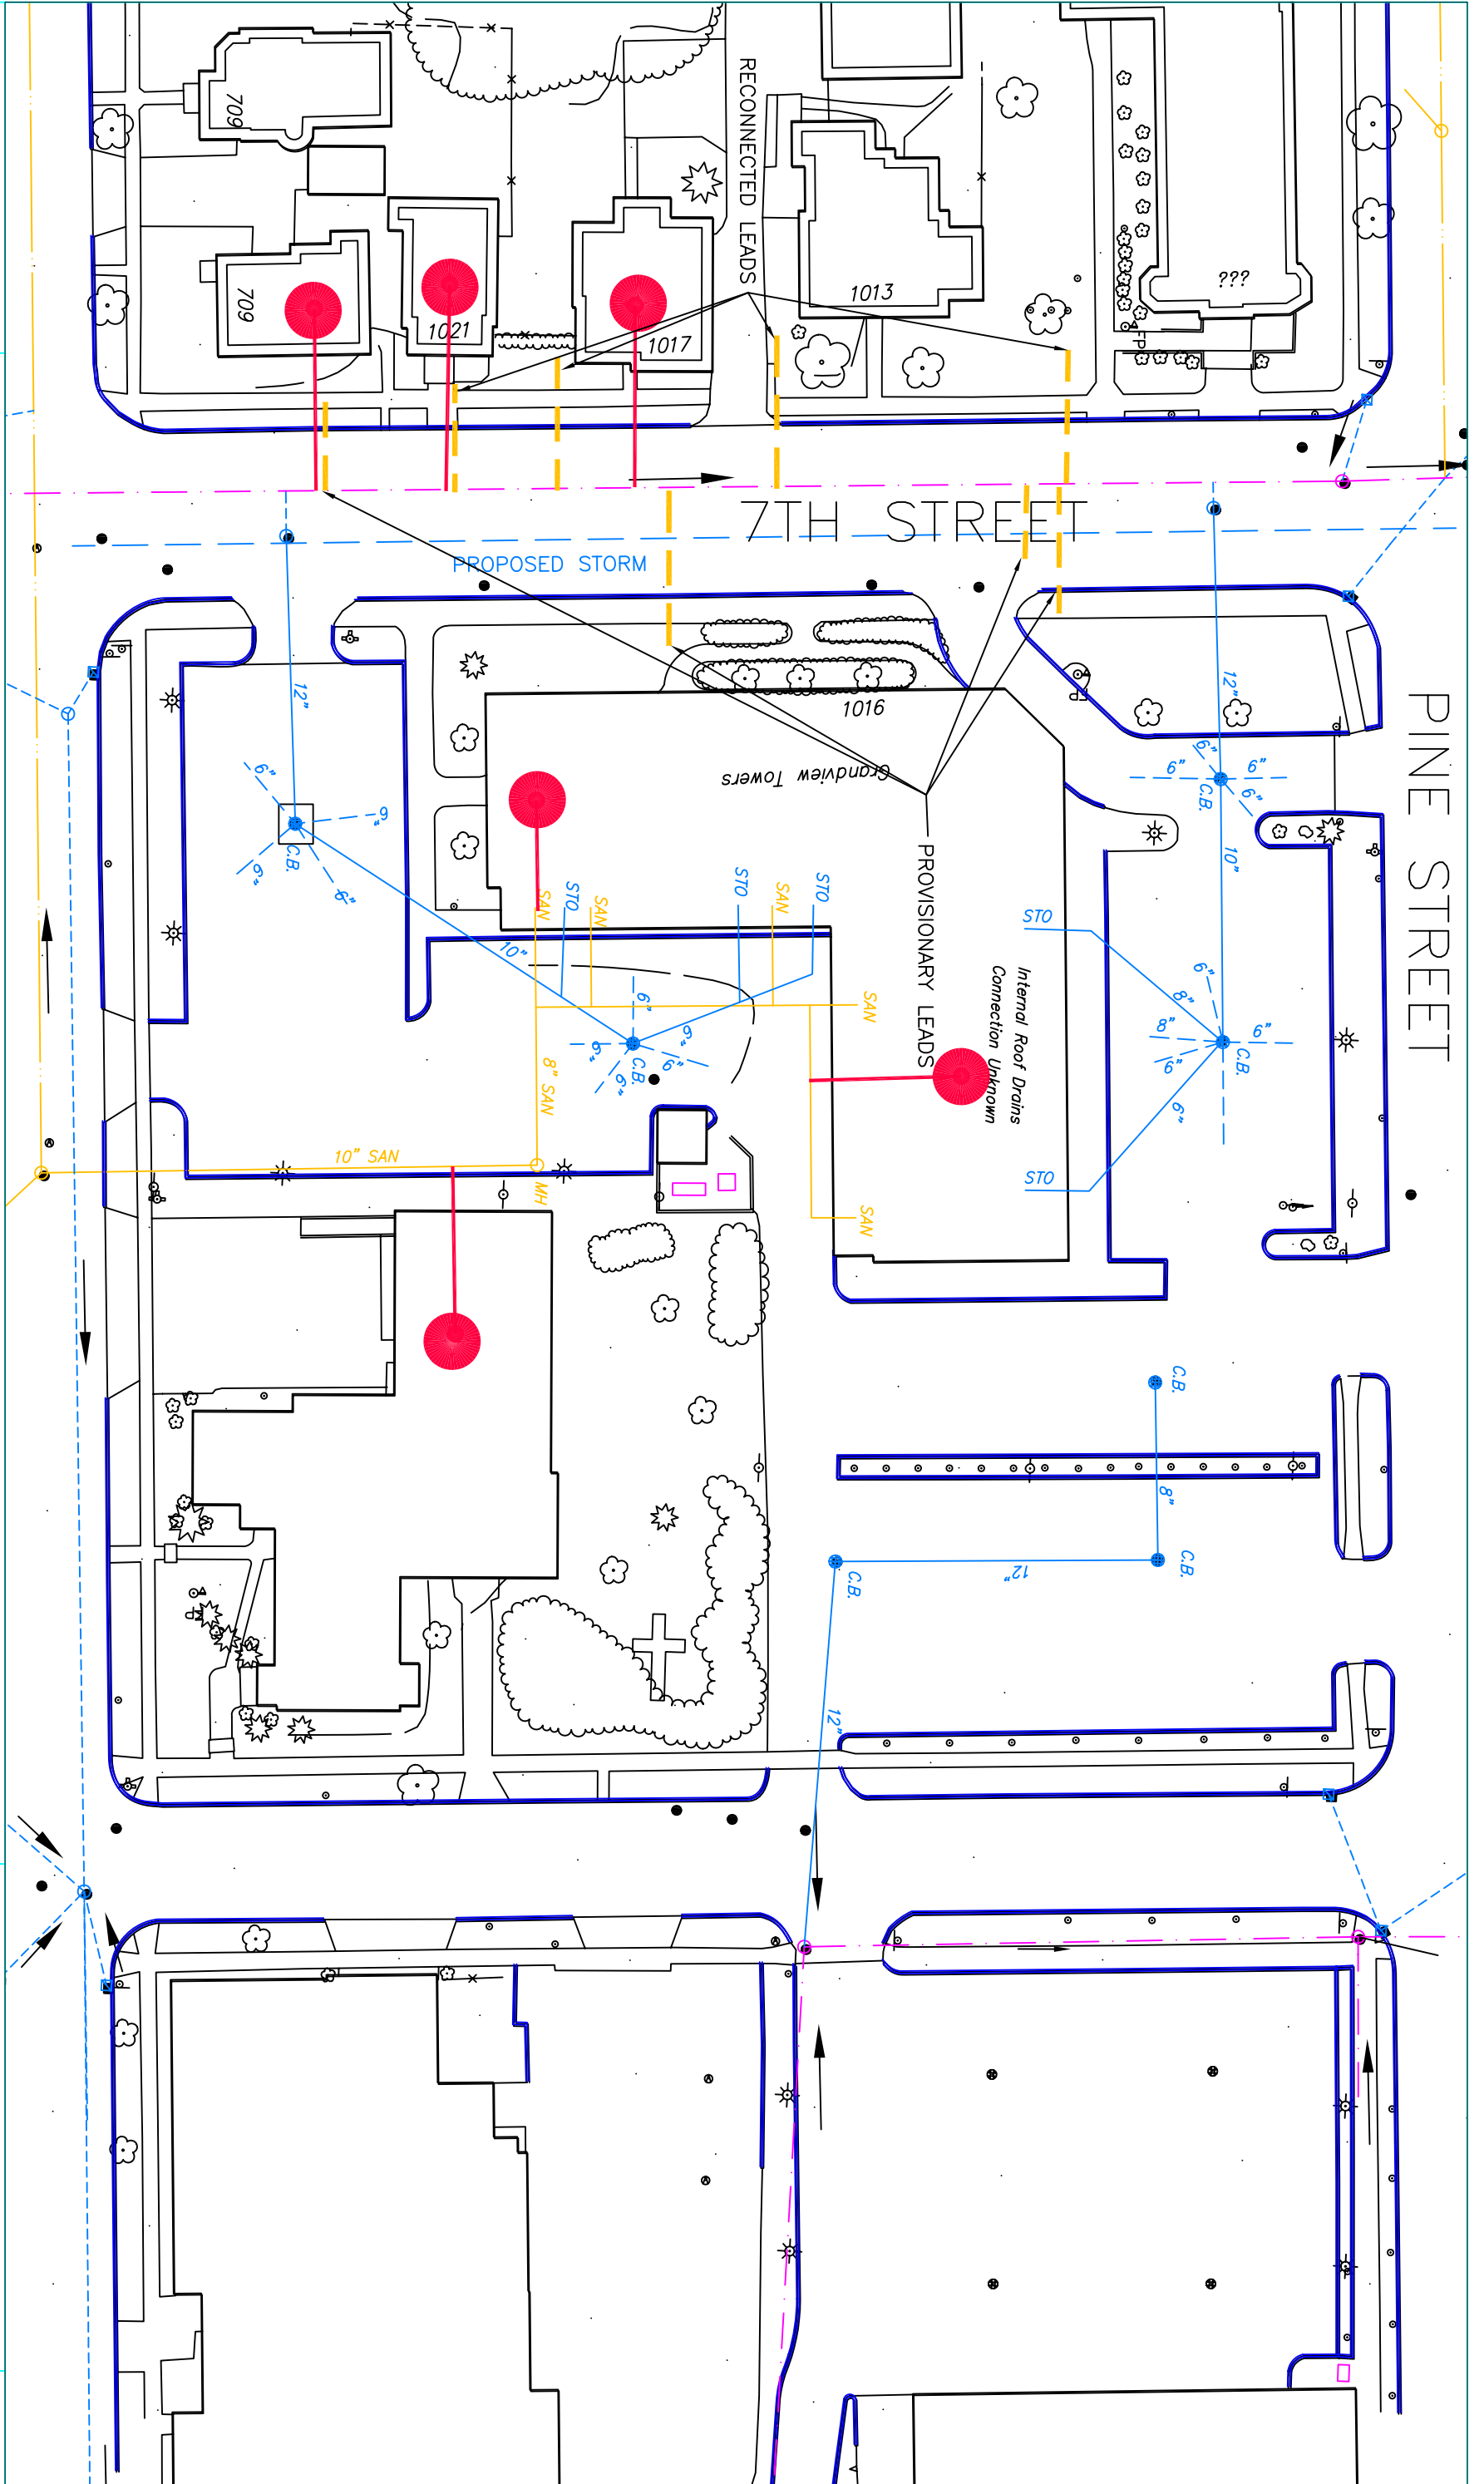
FIGURE
7

Property	Description of Drains on Property.	Recommended Action
1016 7 th Street (Grandview Towers)	Catch basins on property and internal roof drains, refer to Figure 7.	All CBs on property were investigated by city. Results of investigation concludes internal roof drains connect to CBs, refer to Figure 7. All other piping in CBs is for subsurface drainage. The buildings sanitary lead connect to a sanitary sewer, verified through dye testing. City to provide storm sewer from 7 th Street to pick up CB in NW and SW parking lot (this project). City to provide storm sewer on Sixth Street to pick up CB in the NE parking lot (future project).
920 (Office) and 924 (Ruff Floral) 7 th Street	Catch basin on property and possible internal roof drain, refer to Figure 13.	According to site plan, building is separated. City to provide either sanitary or storm sewer in alley to pick up leads.
1928 10 th Street (Mike's Beer * Liquor* Wine).	Catch Basin on property, refer to Figure 14.	Owner must hire plumber to determine CB connection.

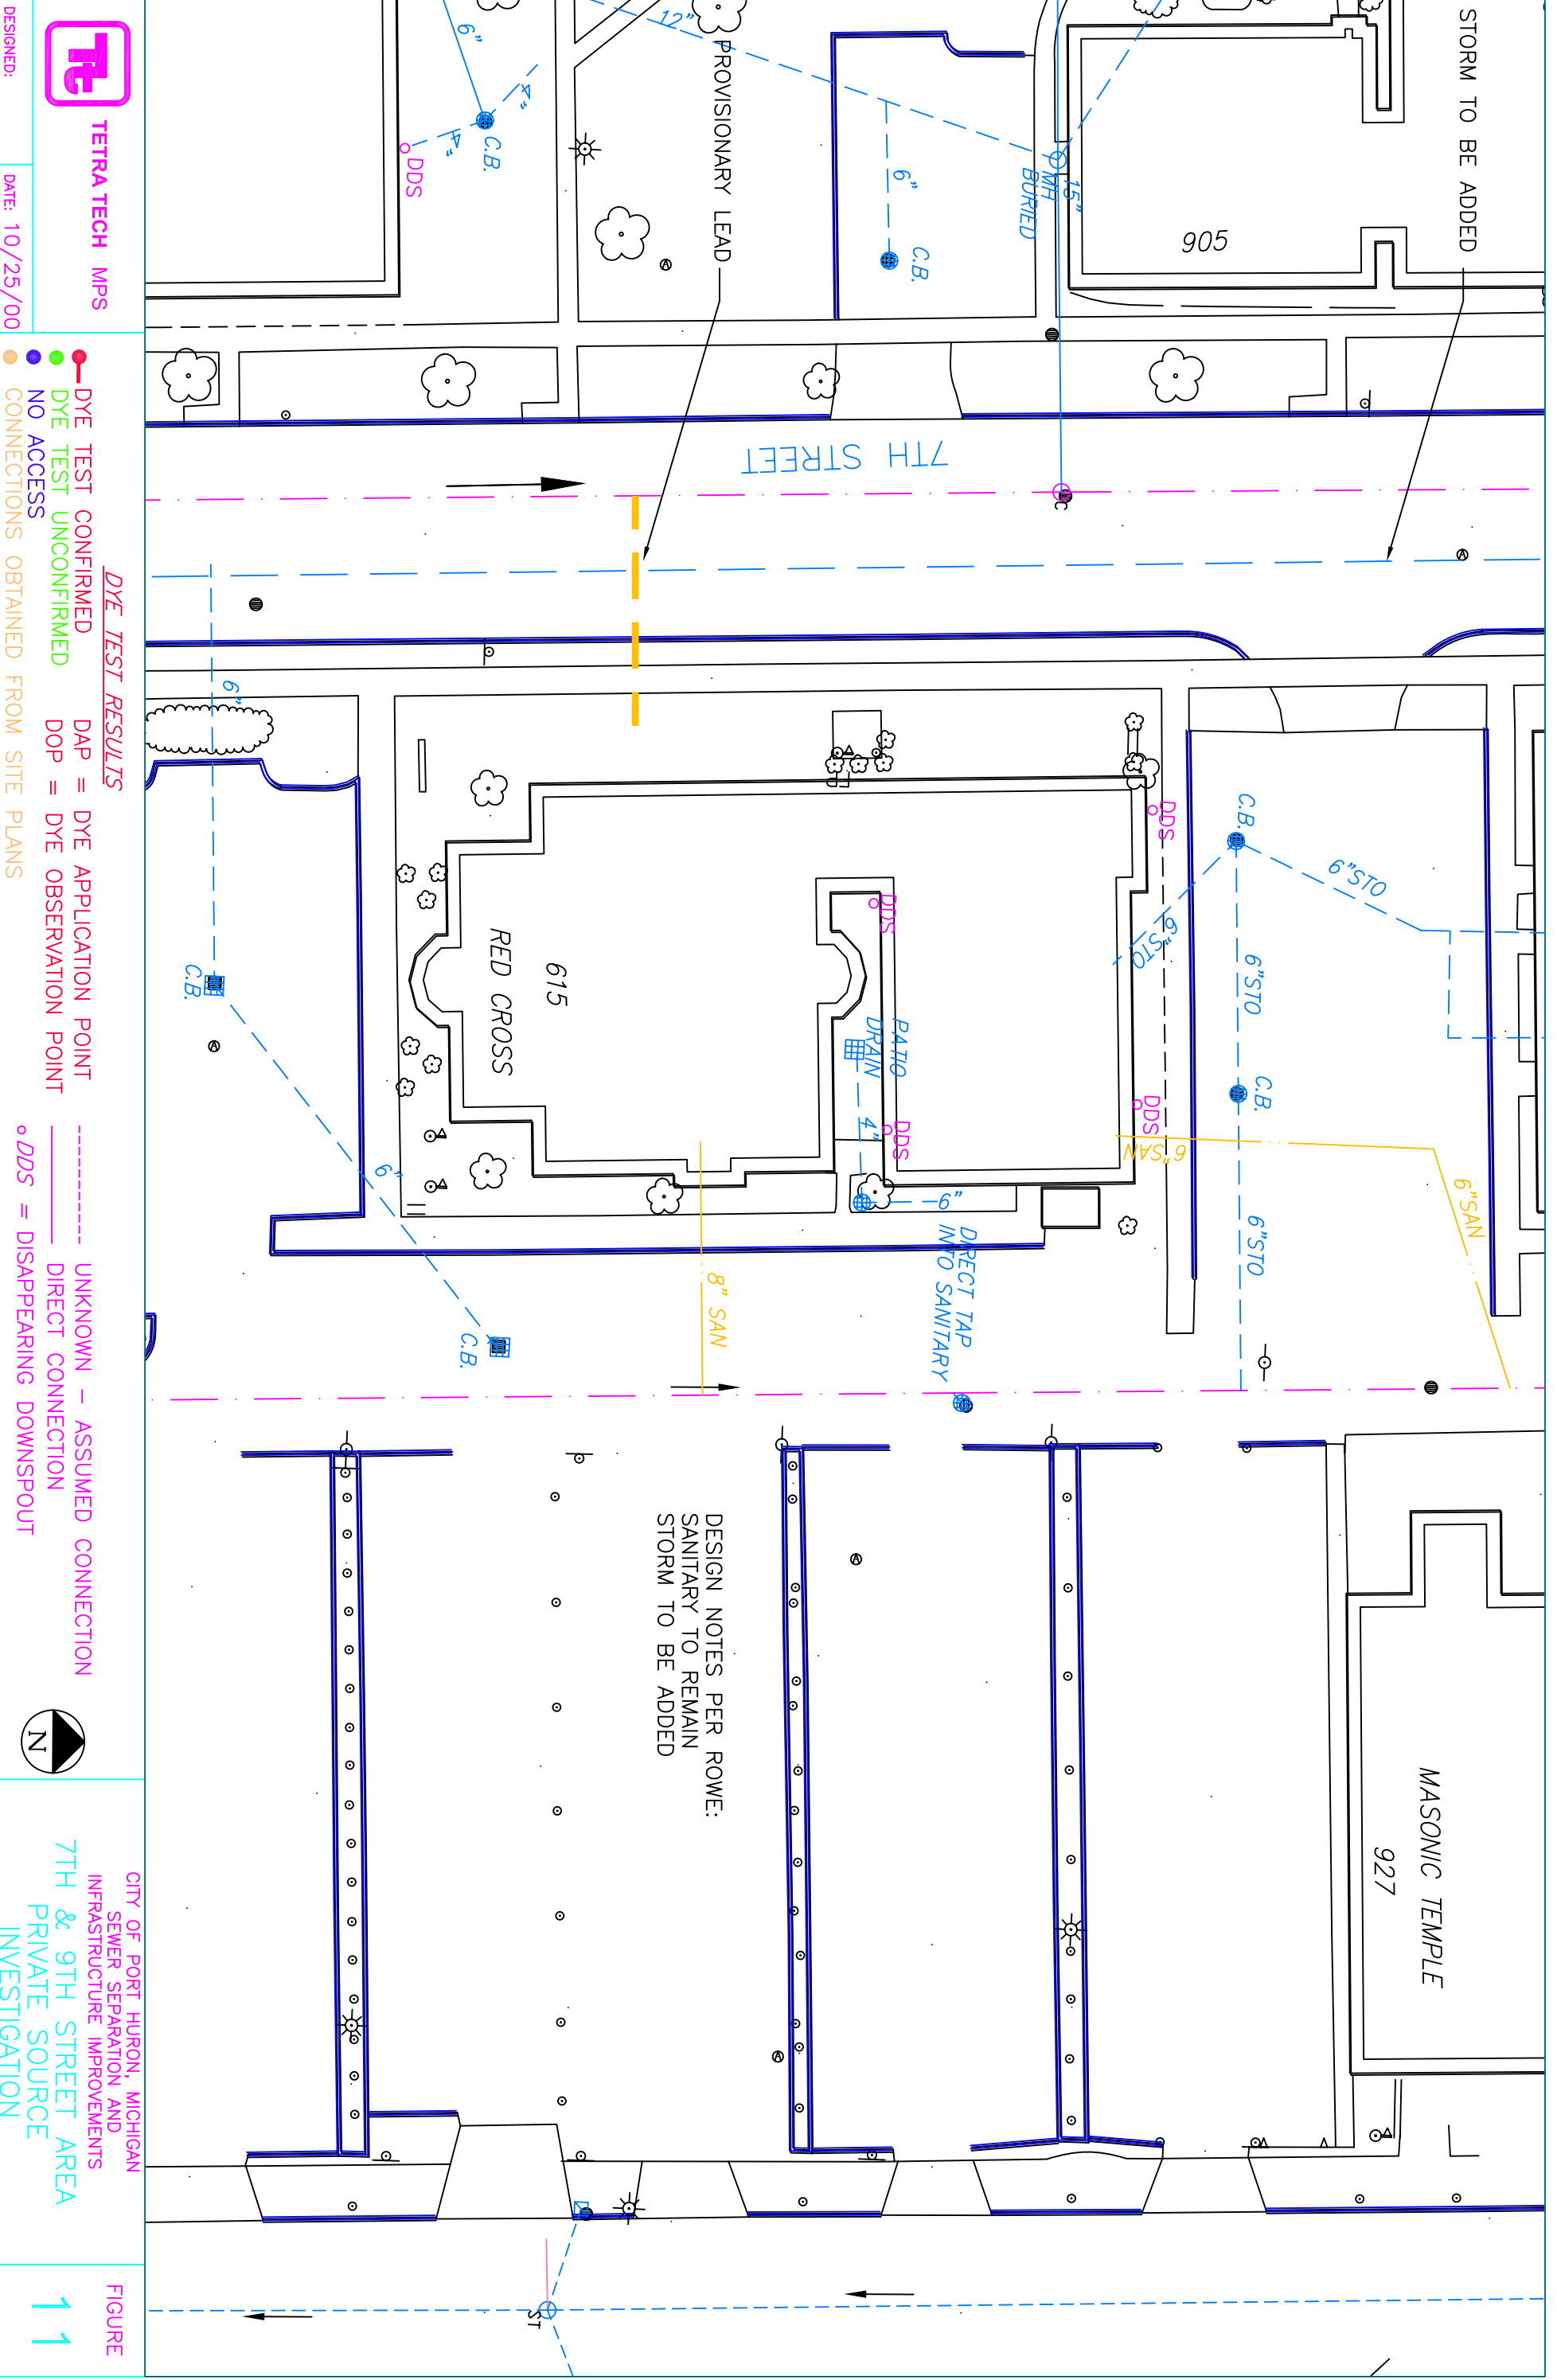
FIGURE 10

933 Lapeer Ave. (AAA Insurance)	Catch basins and disappearing downspouts, refer to Figure 10.	Owner to disconnect downspouts and hire plumber to investigate CB connections.
945 Lapeer Ave. (Kimball Appliance)	atch basin and disappearing downspout, refer to Figure 10.	Owner to disconnect downspouts and hire plumber to investigate CB connections.
615 Pine Street (American Red Cross).	Catch basins, patio drain and disappearing downspouts on property, refer to Figure 11.	According to site plans, storm and sanitary are separate. City to provide storm lead to parking lot. Owner to disconnect disappearing downspouts and hire plumber to determine connection for CB near patio drain.
710 Pine Street	Disappearing downspouts	Disconnect downspouts
811 Pine Street	Disappearing downspouts	Disconnect downspouts
815 Pine Street	Disappearing downspouts	Disconnect downspouts
821 Pine Street	Disappearing downspouts	Disconnect downspouts

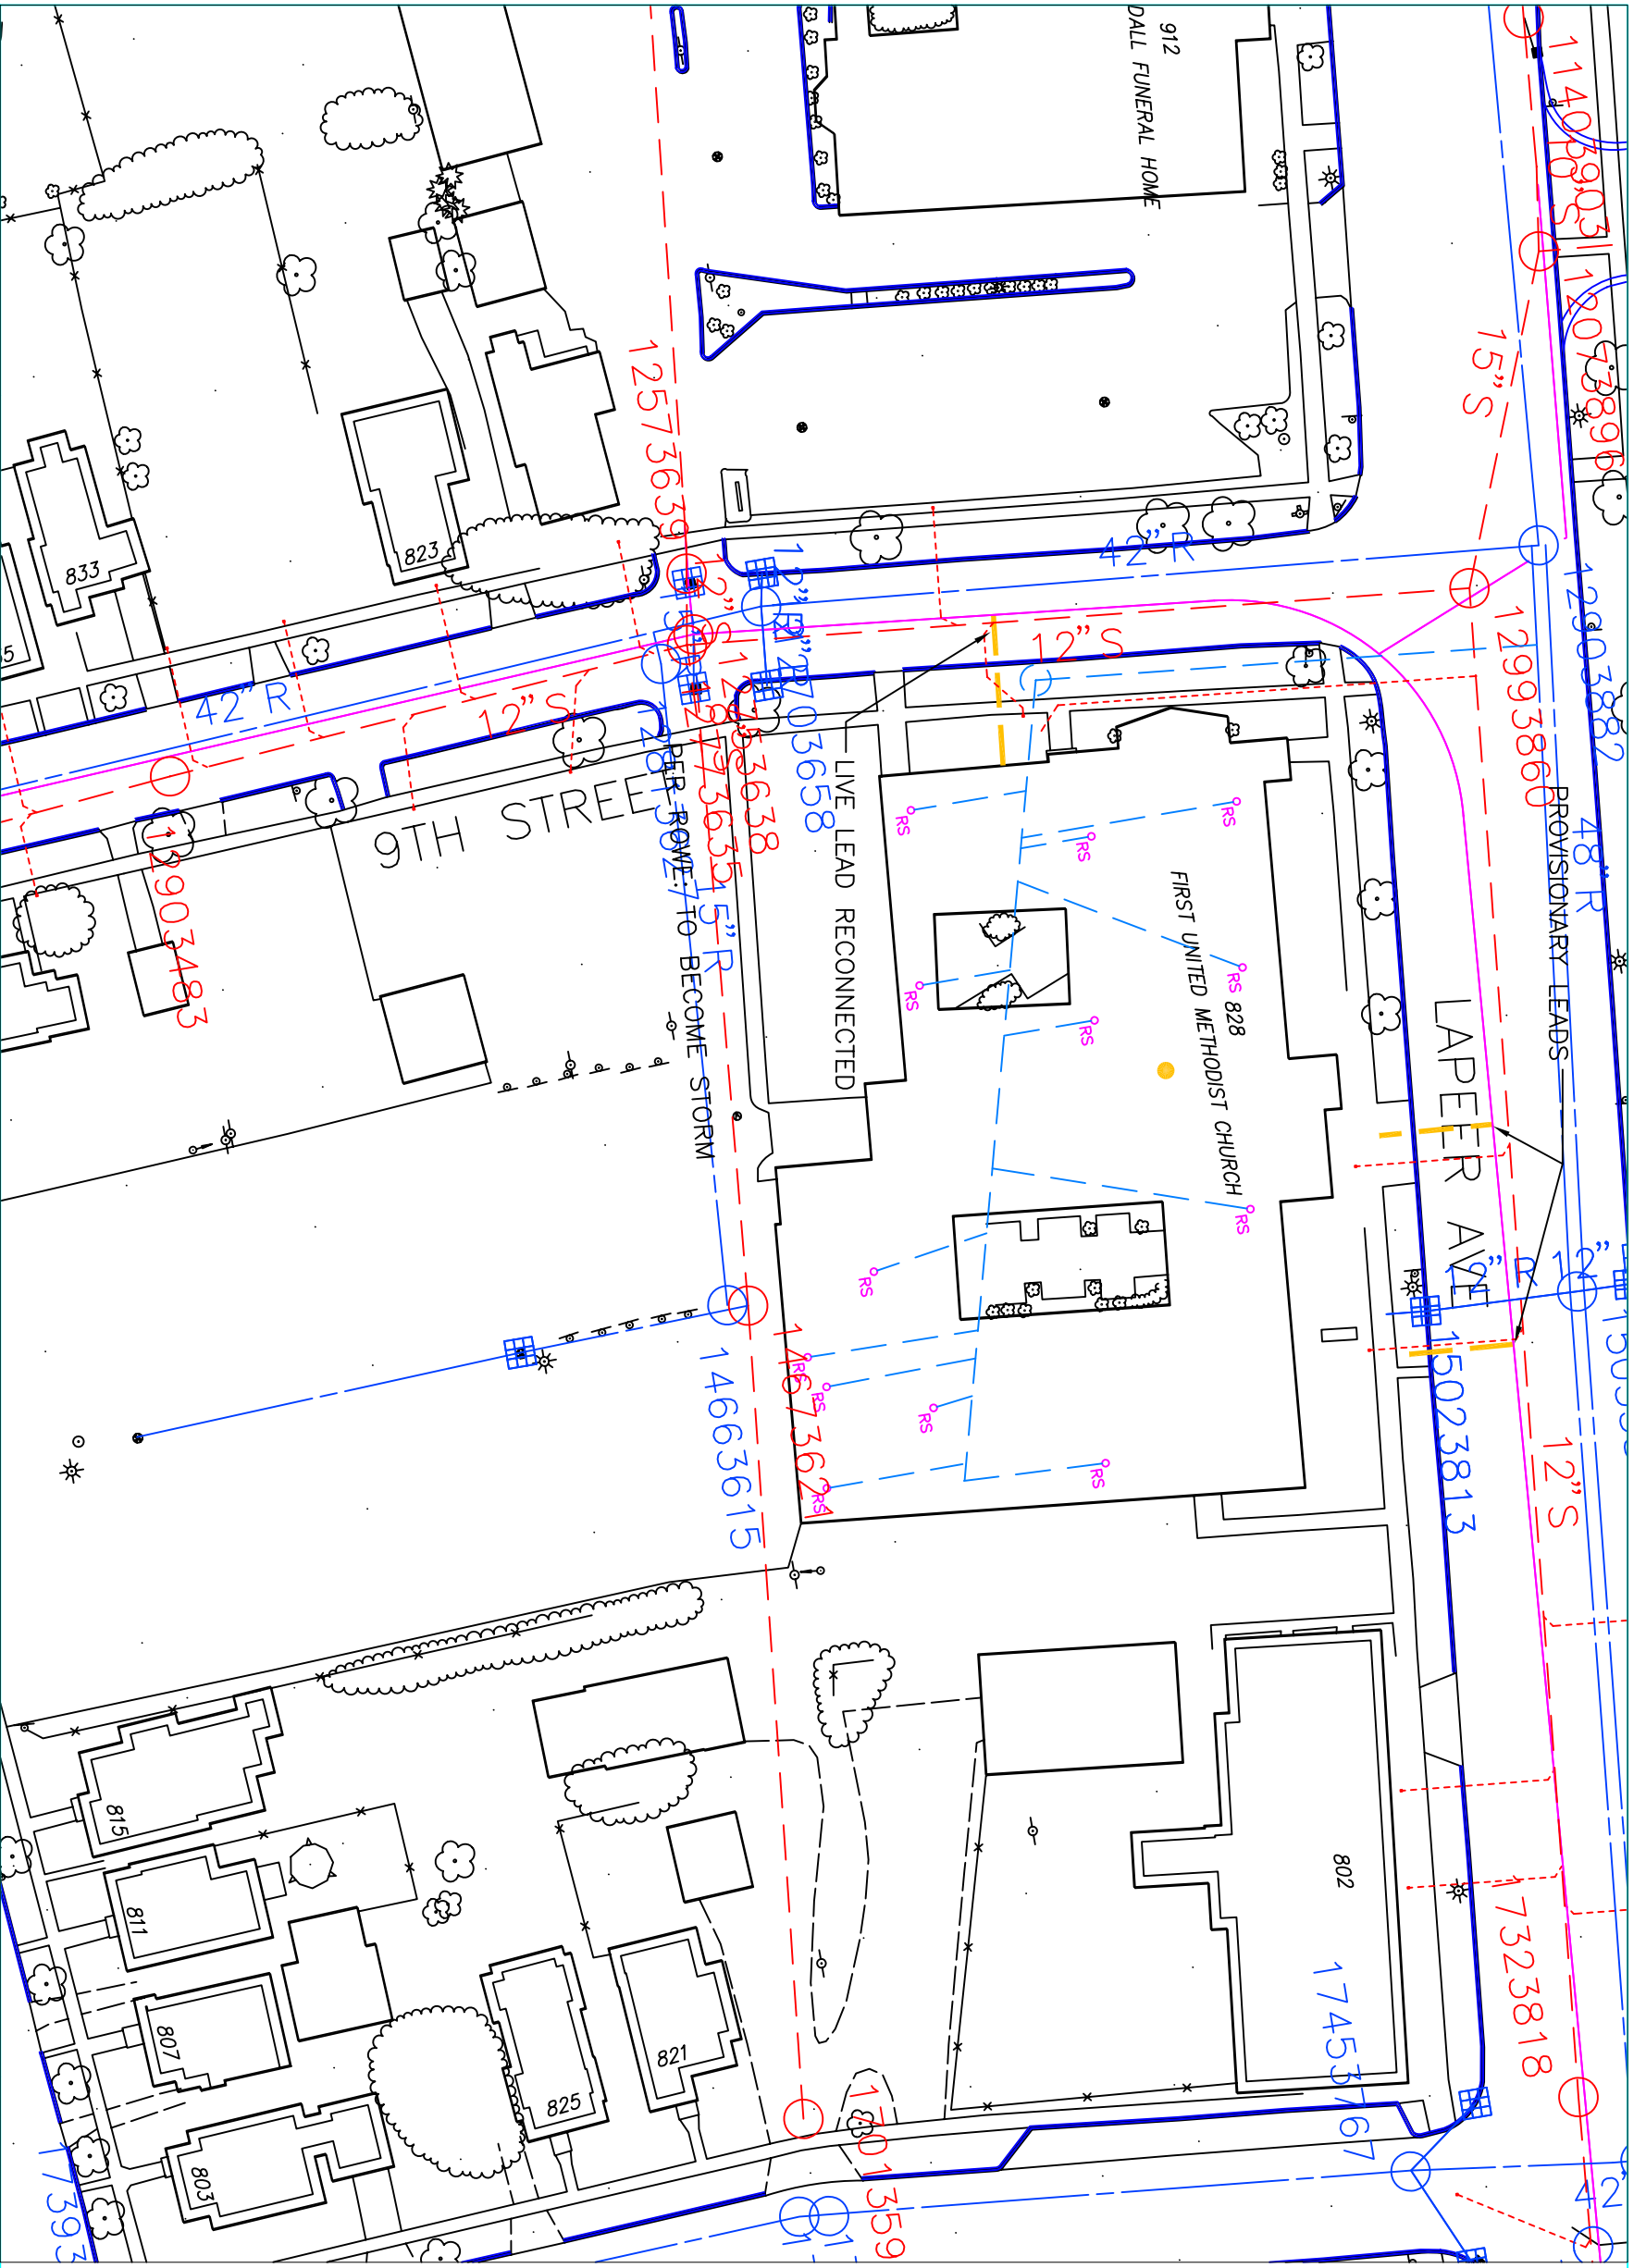
FIGURE
15

1232 10th Street (Tom Manis Restaurant)	Catch basins on property, refer to Figure 15.	Catch Basins in parking lot connect to city CB in street.
828 Lapeer Ave. (First United Methodist Church)	Catch basins on property, refer to Figure 16.	According to site plans, storm and sanitary are separate. City to provide either storm or sanitary to building. City to also provide storm lead to parking lot CBs.
912 Lapeer Ave. (Pollack-Randall Funeral Home)	Catch basins on property, refer to Figure 17.	City to provide storm lead for CBs in parking lot.

NOTE:
828 LAPEER - UNITED
METHODIST CHURCH
